6th Street SSO Elimination

Phase I

City of Hoopeston, IL

October 04, 2016

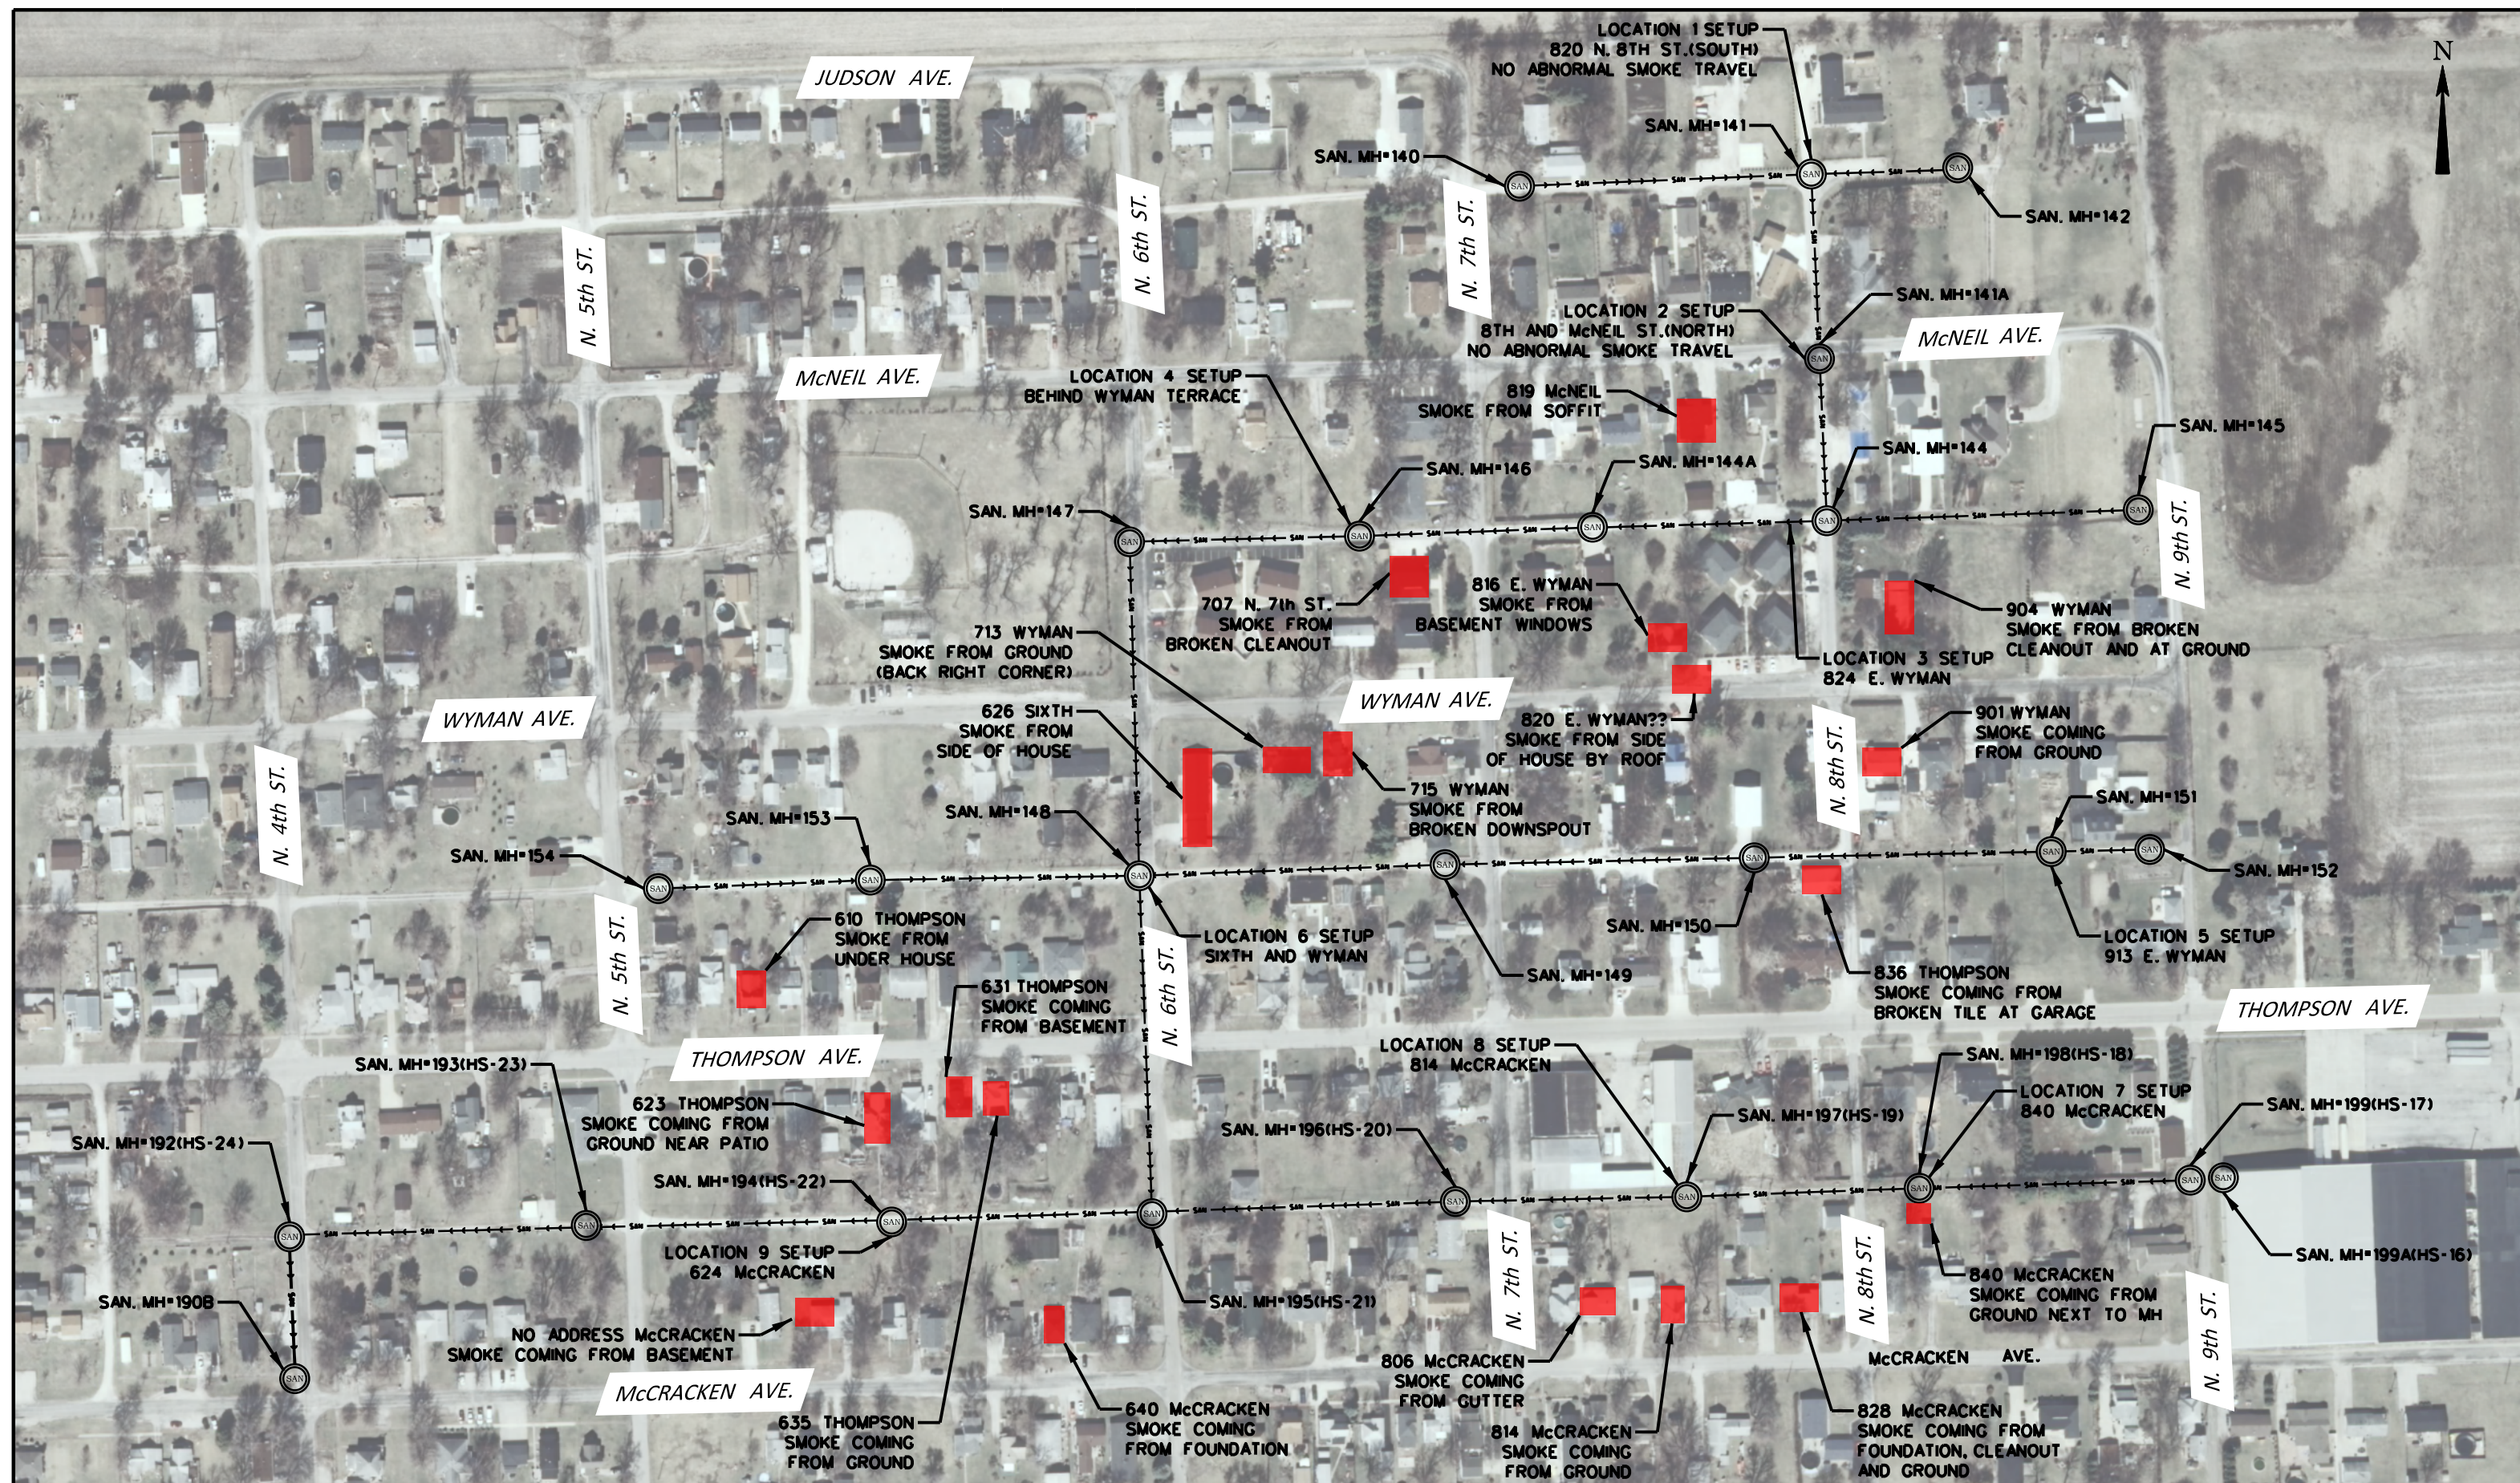
PROJECT NAME:	6th STREET SSO STUDY
SHEET TITLE:	SMOKE TESTING RESULTS

Approximately nine locations of smoke exiting at ground level were found in the study area, indicating the private lateral is defective (cracked, broken or has root intrusion). Five cleanout locations were observed to have smoke presence, indicating that the cleanout is broken or uncapped. Two locations of gutter/downspout tie-ins were found, this is a direct connection between storm water flow and the sanitary sewer. Eight locations of smoke exiting through basements/foundations were observed, indicating defective plumbing pipes or cross connections with floor drains. Defective private plumbing is hazardous to the homeowner because sewer gases are leaking at these points that smoke is observed.

Private sewer rehabilitation is another issue that the City will need to address. Smoke testing revealed several locations on private property that are contributing unwanted flows to the system. The repairs necessary to correct the problems include lining the existing laterals, open cutting and replacing service lines, connection repairs, disconnection of downspouts, and repairs to defective plumbing pipes inside the home. The City will need to decide if the rehabilitation costs should be included with a public sewer improvement project or if it will be the responsibility the individual homeowners. The cost of each private sewer repair may vary from \$500 to \$3,500. An average cost of \$1,250 was used per repair for the purpose of the cost estimate included in this study.

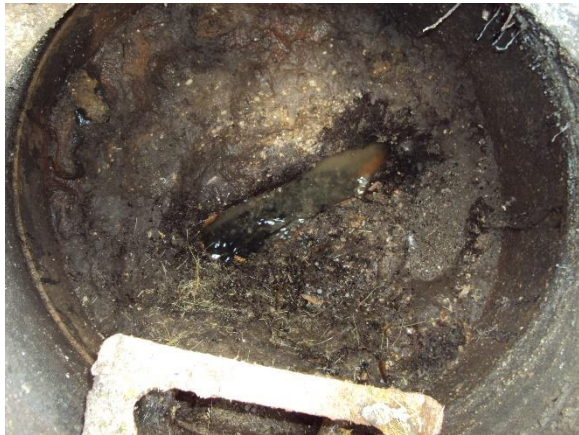
MH 194: Full of Debris, Roots, Joints Leaking

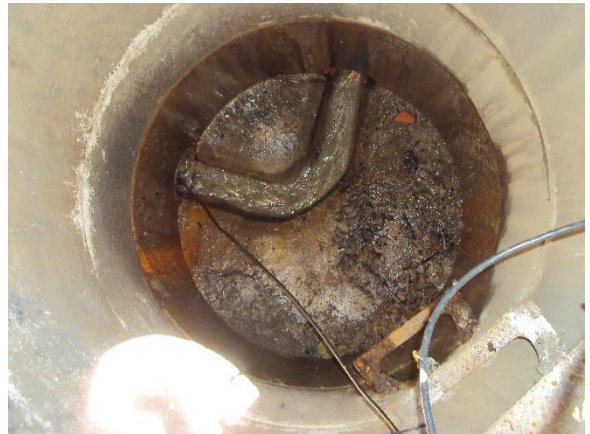
MH 147: Infiltration at Barrel Section

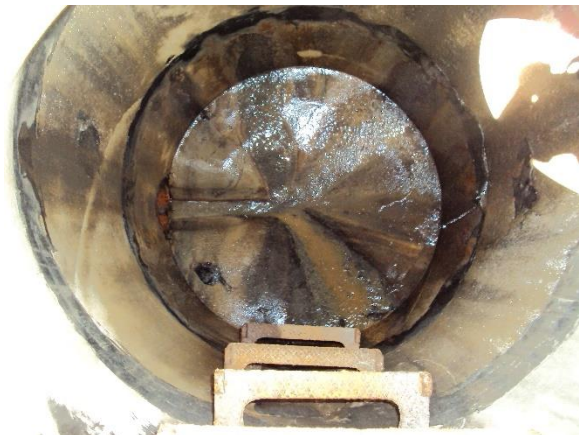
MH 145: Major Infiltration at Joints Leaking

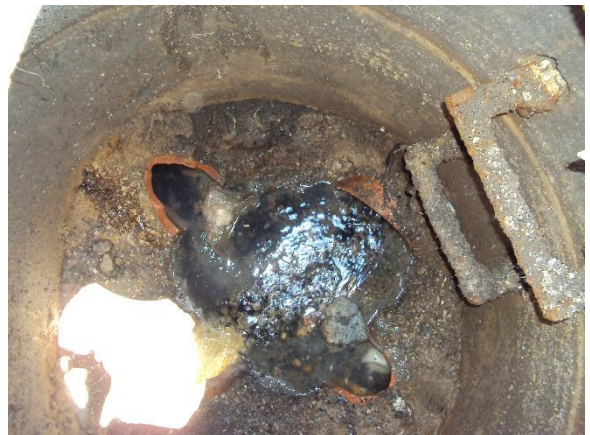
MH 148: Buildup in Invert, Signs of SSO's

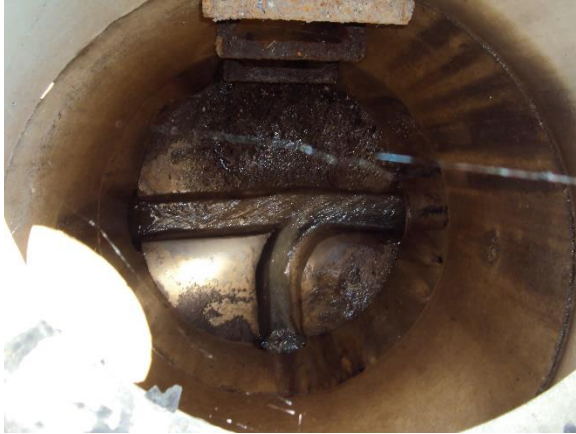
MH 144: Infiltration at Joints, Lifting Holes, Invert Needs Patched

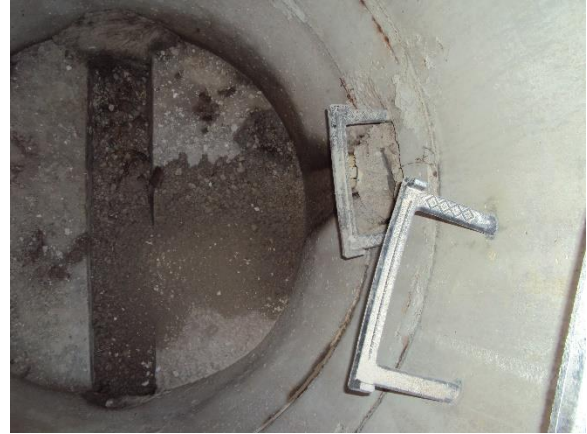
MH 140: Rings and Casting Offset, Full of Debris and Needs Adjusted to Grade

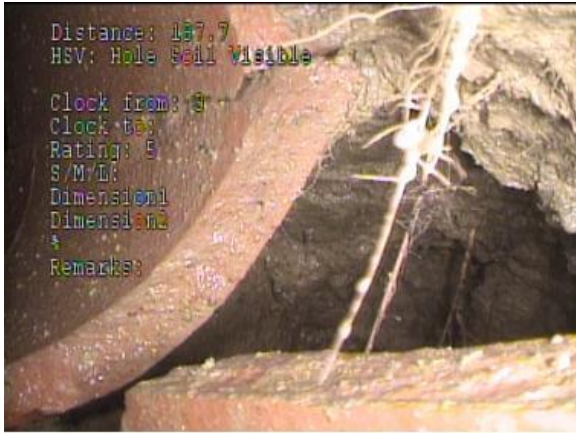
MH 142-141: Break in Pipe near MH 142

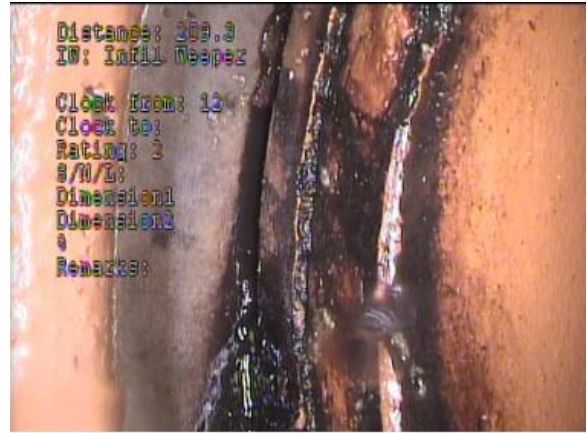
MH 145-144: Leaking at Joint

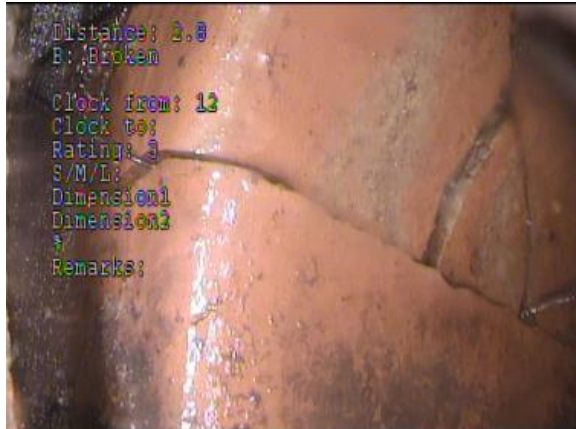
MH 146-147: Break in Pipe near MH 146

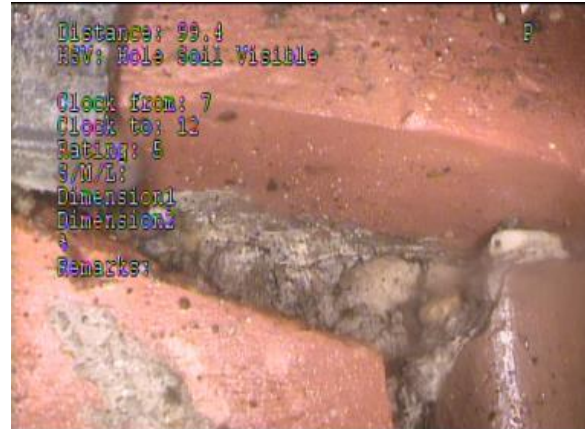
MH 150-151: Break in Pipe 100' from MH 151

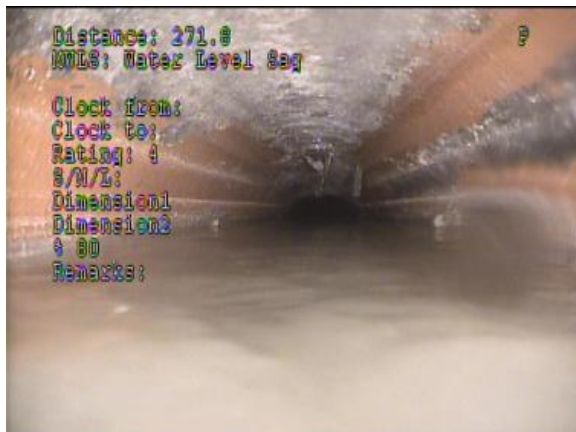
MH 147-148: Sag in Pipe

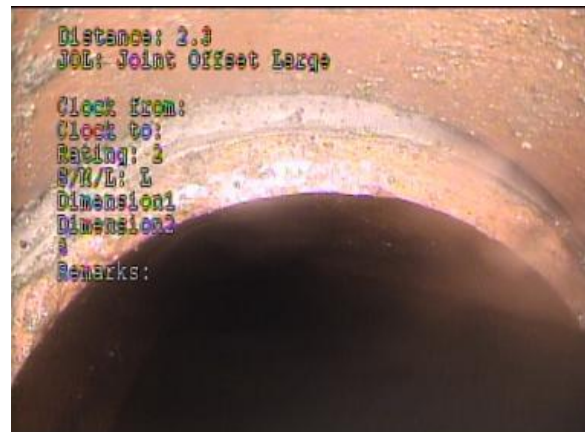
MH 151-152: Joint Offset near MH 151

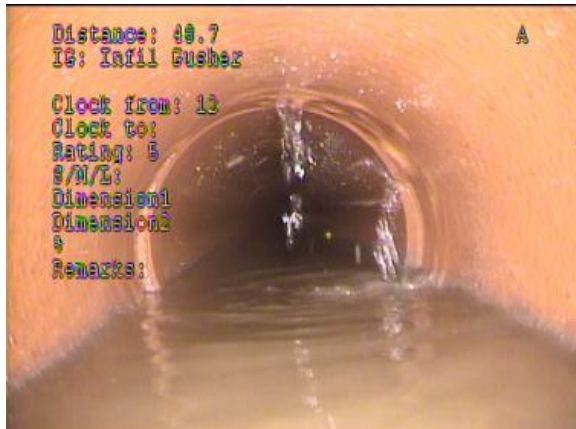
MH 153-148: Infiltration at Joint

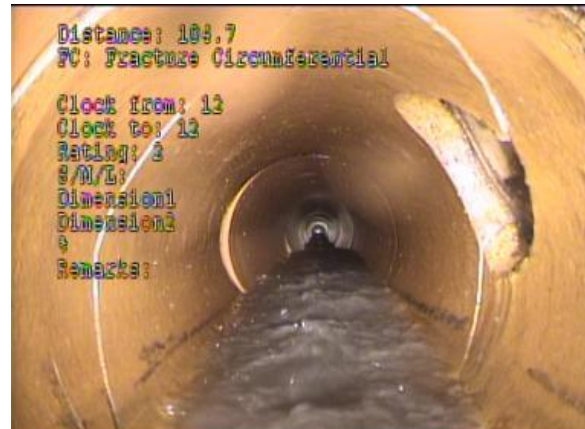
MH 195-194: Circumferential Cracking at Lateral

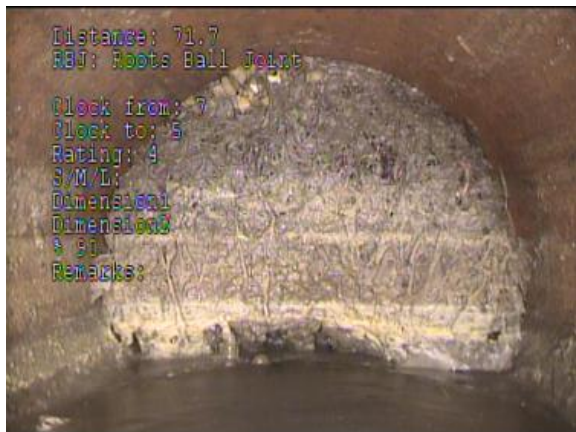
MH 198-197: Major Root Intrusion

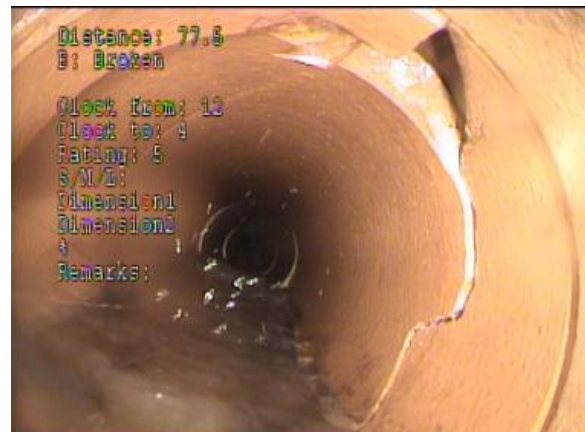
MH 193-192: Break in Pipe, 77' from MH 193
