6th Street SSO Elimination

Phase I

City of Hoopeston, IL

October 04, 2016

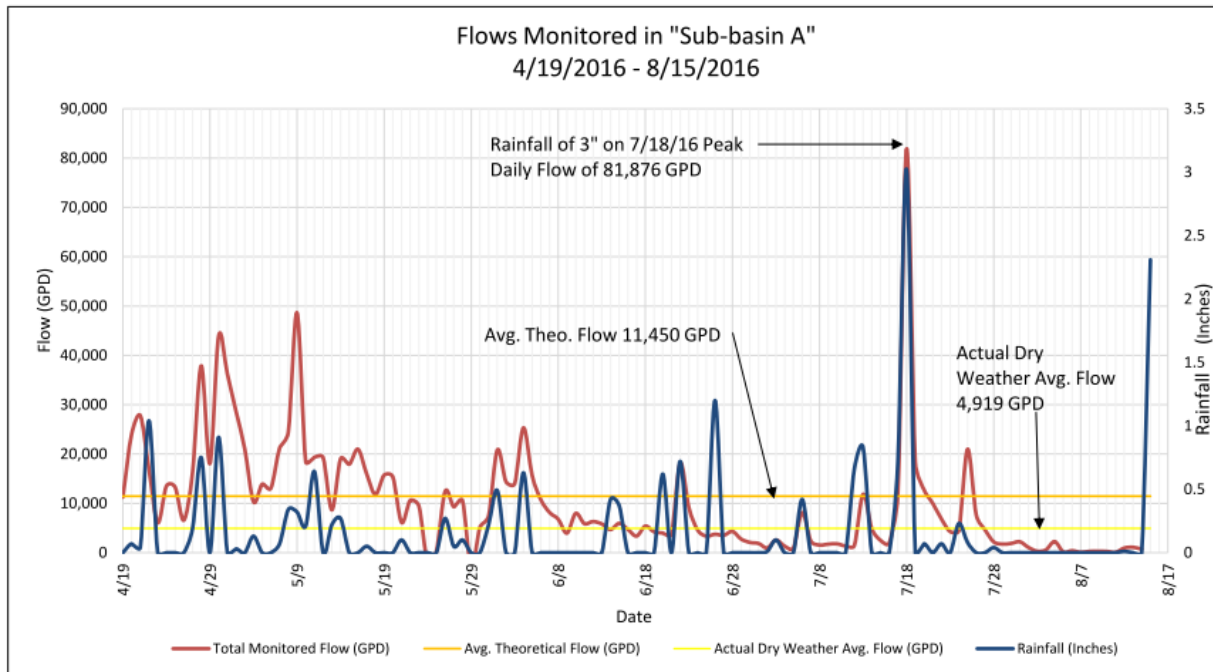
Graph 1A: Sub-basin A Flows and Rainfall Data

Manholes 199A through Manhole 195 contribute flows to Sub-basin A. Sub-basin A has approximately 1,392 linear feet of 8" sewer and encompasses the area east of Sixth Street to Ninth Street from the south side of Thompson to the north side of McCracken Ave. The total daily monitored flow has peaks corresponding to rain events with a steep decrease towards the dry weather average, this is an indication that inflow is a large contributor of unwanted flow. Sub-basin A has the largest wet weather peak of the three areas at 16.6 times that of the average dry weather flow.

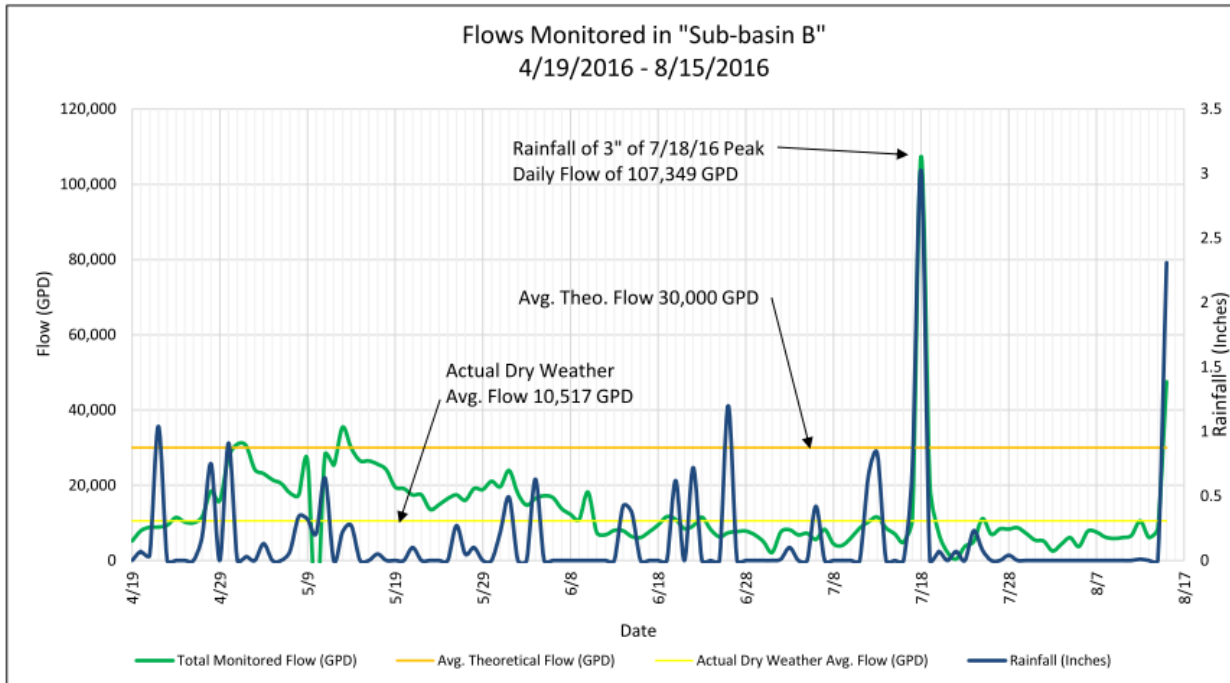
Graph 2A: Sub-basin B Flows and Rainfall Data

Manholes 147 through 154 and the run from 148 to 195 contribute flow to Sub-basin B. Sub-basin B has approximately 2,808 linear feet of sewer and serves the area east of Fifth Street to Ninth from south Wyman Ave. to north Thompson. A monitor placed in the north invert of Manhole 195 captured data from both Sub-basin B and Sub-basin C combined, by subtracting data collected for Sub-basin C from data collected in the north invert of 195 we were able to isolate the area for Sub-basin B. The total daily monitored flow indicates infiltration is a large source of wet weather flow in Sub-basin B. The peak wet weather flow is 10.2 times the dry weather average flow in this area.

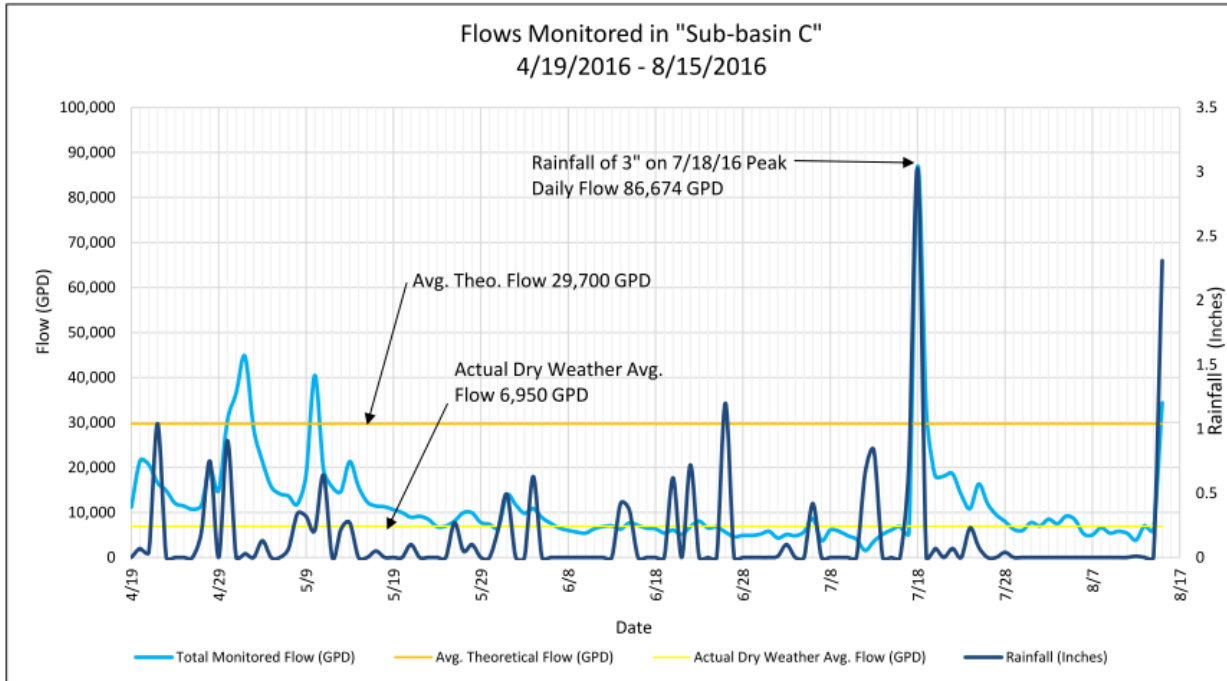
Graph 3A: Sub-basin C Flows and Rainfall Data

Manholes 140 through 147 contribute flow to Sub-basin C. Sub-basin C has approximately 2,330 linear feet of 8" sewer, serving the area east of Sixth Street to Ninth from Wyman Ave. to McNeil Ave., as well as east of Seventh St. to Ninth St. from McNeil Street to Judson Ave. The total daily flows collected in this sub-basin indicate that infiltration is a large contributor of unwanted flow. With more frequent rain events and saturated ground conditions, rainfall has a greater impact on infiltration and inflow problems than when the ground is unsaturated and has the ability to absorb more water. The peak wet weather flow in this sub-basin is 12.5 times the dry weather average flow.

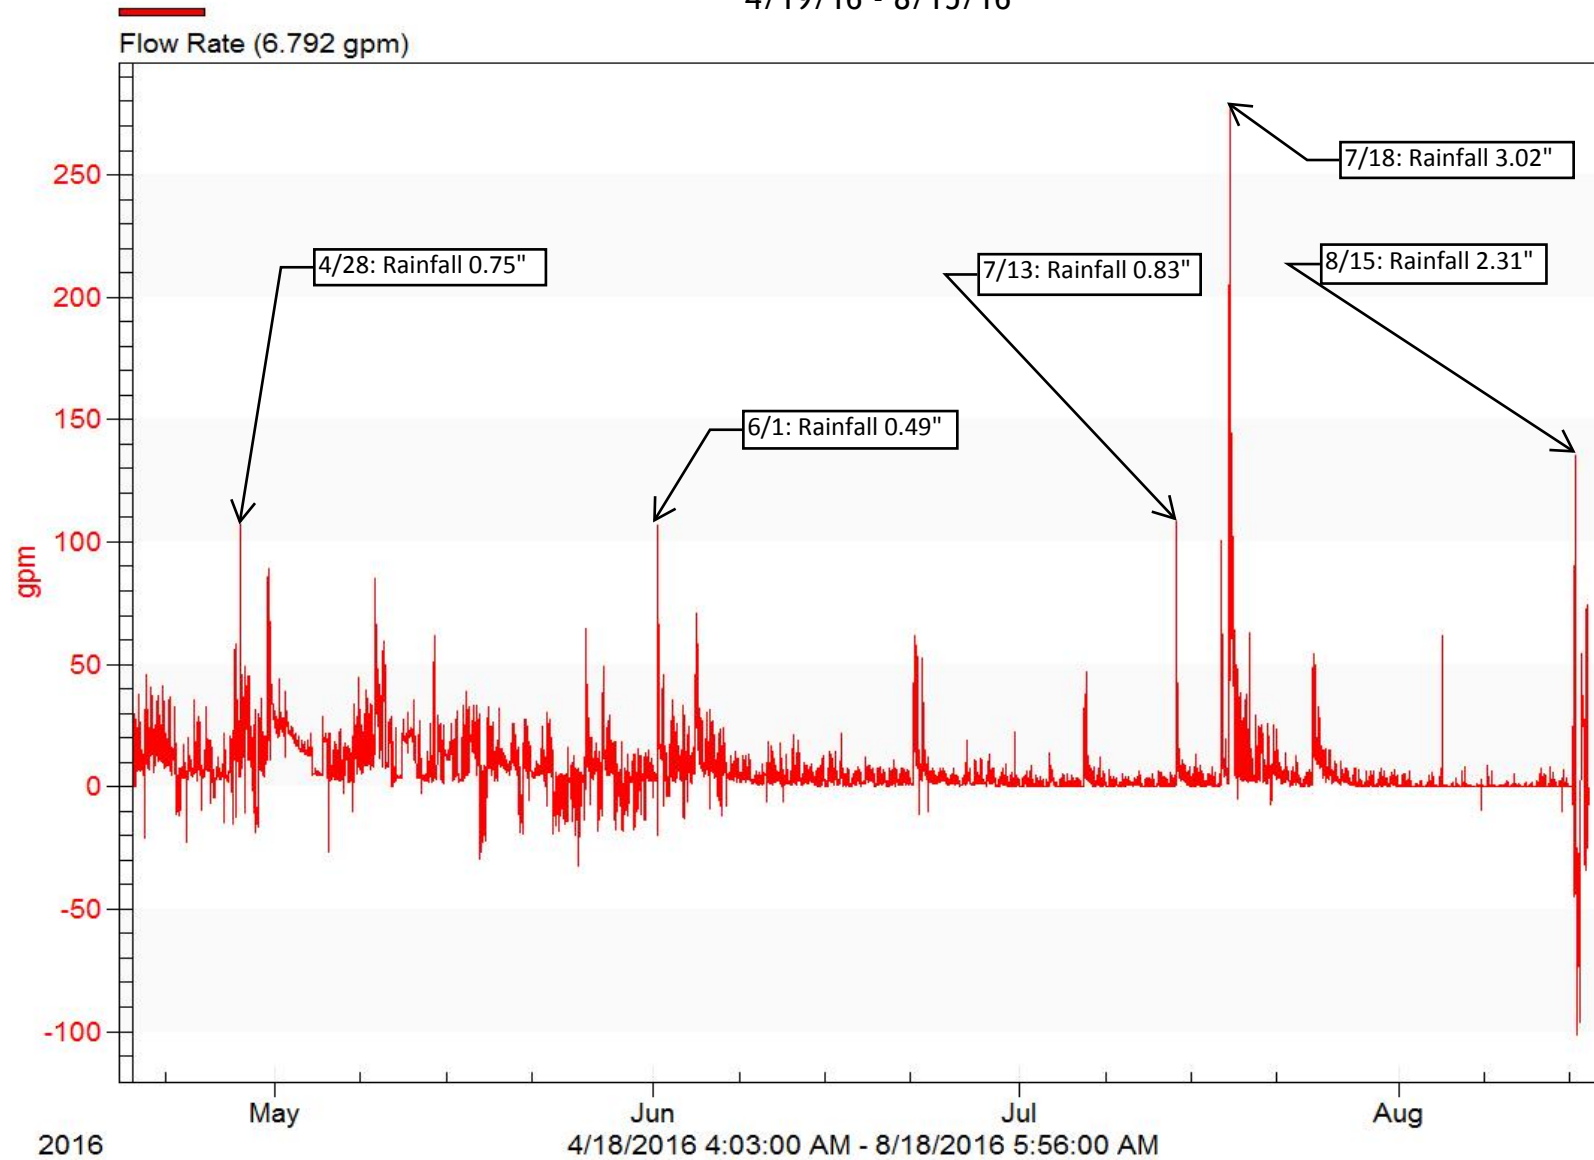
Graph 1B
Monitored Flow Rate
Sub-basin A
4/19/16 - 8/15/16

Graphs 1B-1D attached in Appendix A, show the instantaneous flow rates for Sub-basin A. Graph 1B shows the instantaneous flow for the duration of the monitoring period, flow noticeably changes as the result of both large or small amounts of rainfall. The 7/18/16 rain event caused an increase of flow by 39.6 times in a period of 2 hours, seen in Graph 1D; Graph 1C is included to show flow rates without rain during the same time frame a week prior. The change in flow from 4:30 am to 6:30 am increases by 2 times on a day without any rain. Sub-basin A experiences excessive I&I during storms.

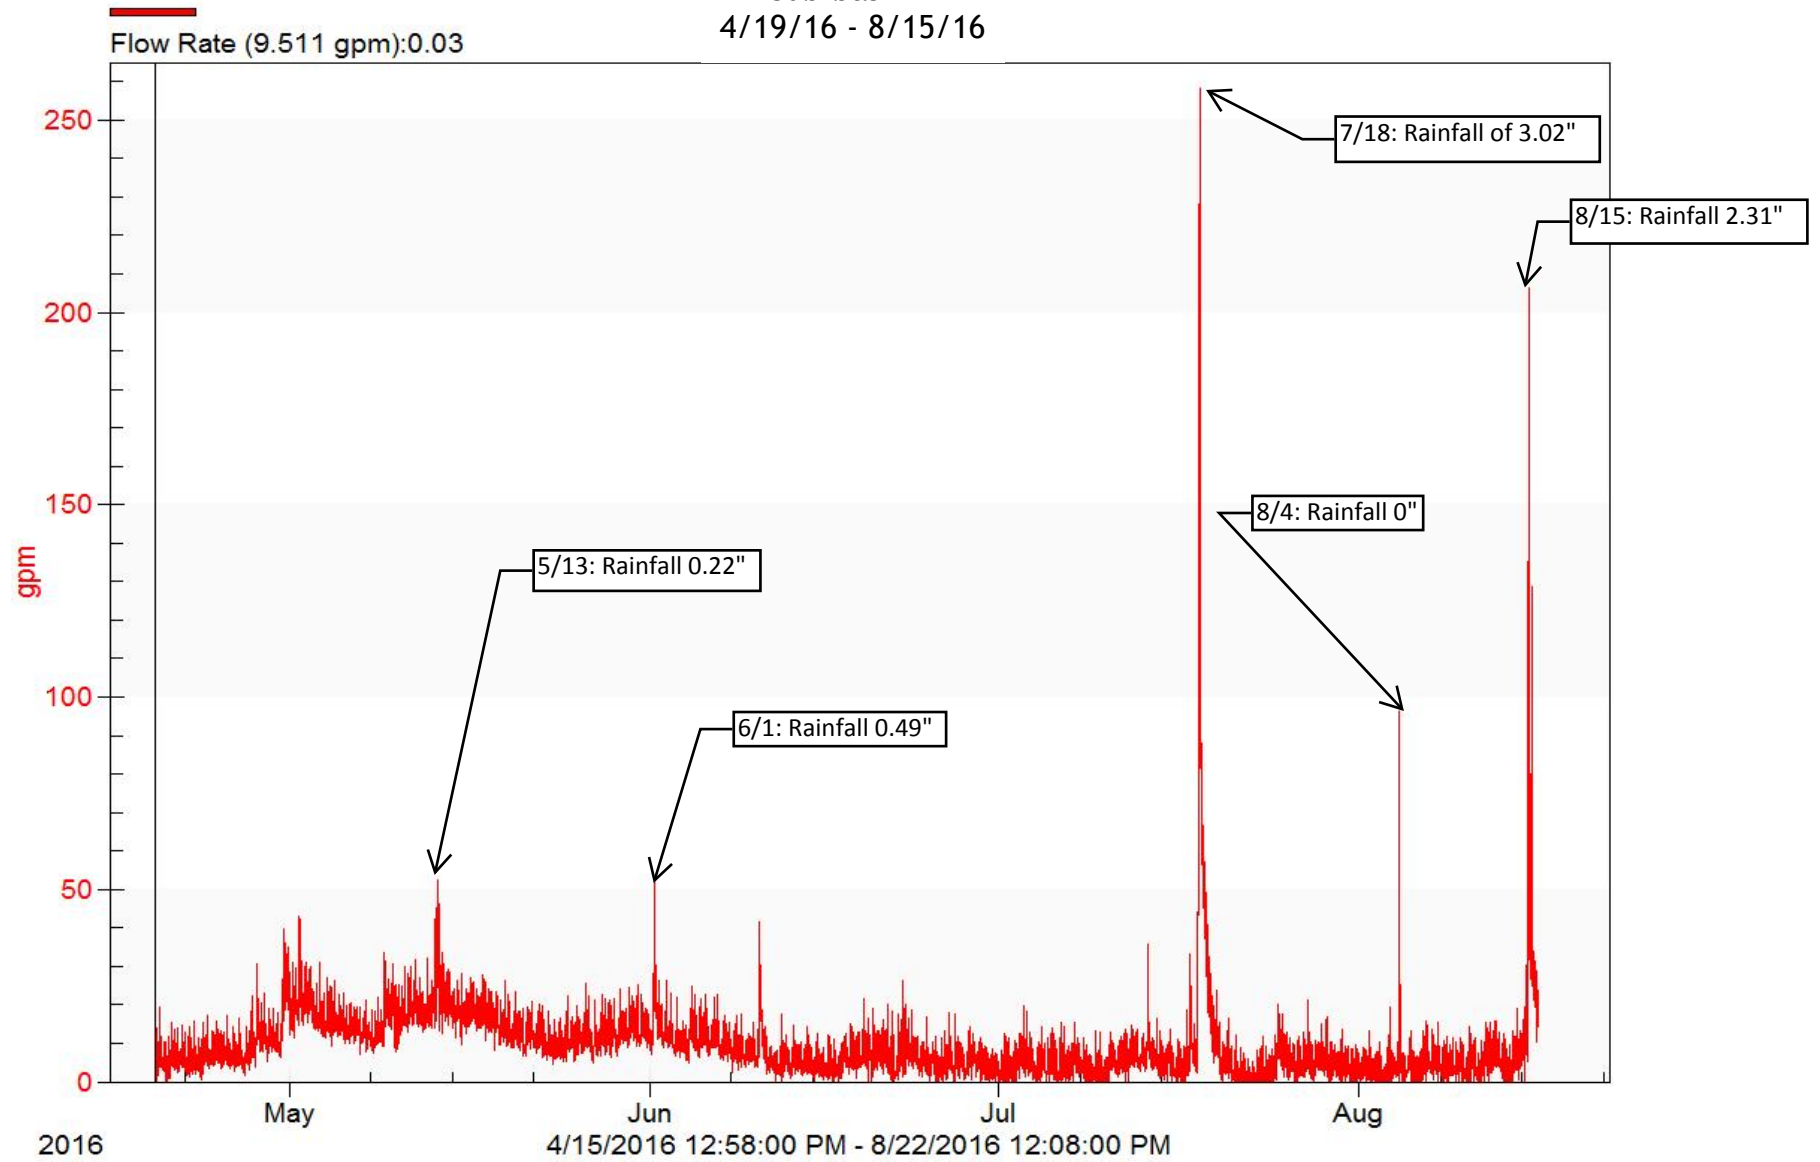
Graph 2B
Monitored Flow Rate
Sub-basin B
4/19/16 - 8/15/16

Graphs 2B-2D attached in Appendix A, show the instantaneous flow rates in Sub-basin B. The 7/18/16 rain event caused an increase of flow by 26 times in 3 hours of time shown in Graph 2D; again Graph 2C is included to show flow rates for the week prior during the same time frame as a typical flow rate without rain. The change in flow was 1.2 times during this period without rain. This sub-basin also has excessive I&I entering the system.

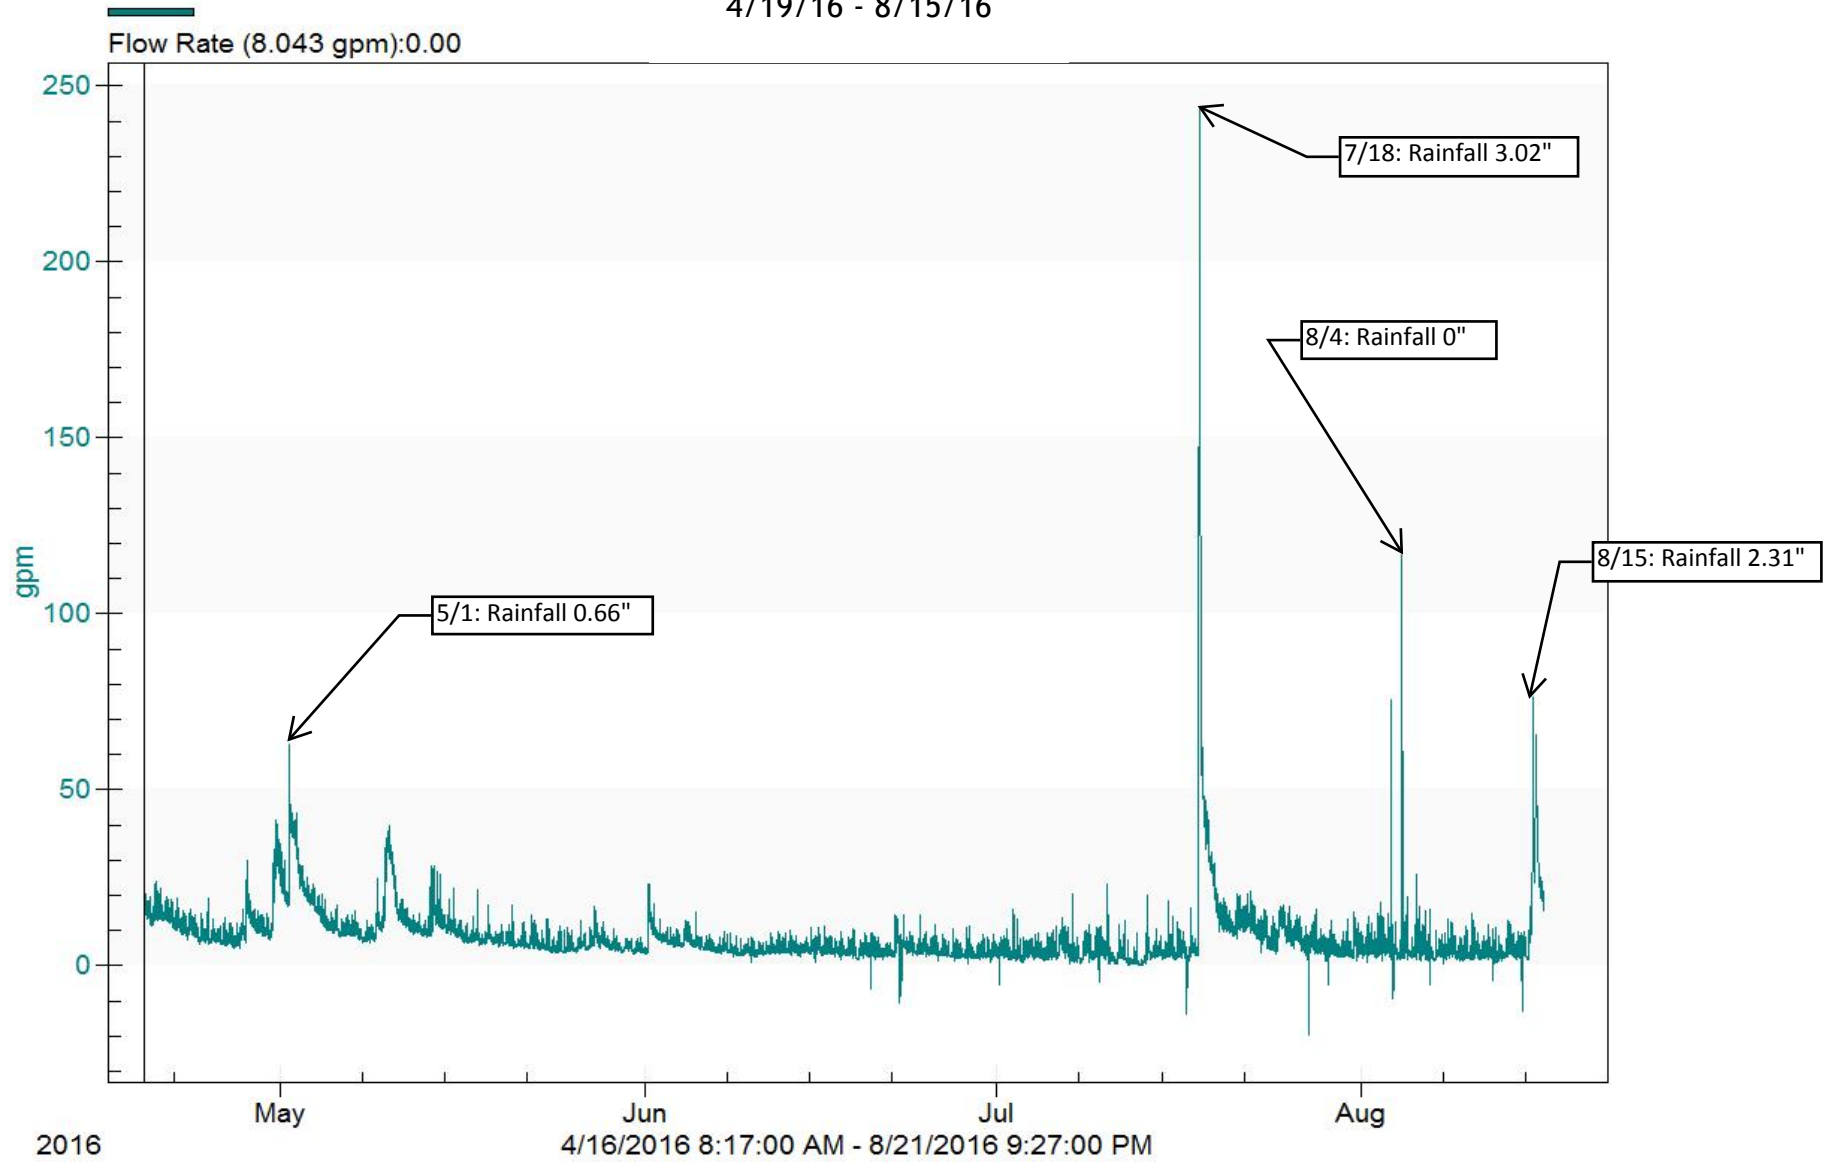
Graph 3B
Monitored Flow Rate
Sub-basin C
4/19/16 - 8/15/16

Graphs 3B-3D attached in Appendix A show the instantaneous flow rates in Sub-basin C. The 7/18/16 rain event caused an increase of flow by 81 times over a 3 hour duration as seen in Graph 3D. An increase of flow by 5.8 times occurs on a normal day without rain as seen in graph 3C.
